**JOHN F. KENNEDY
SPACE CENTER**

MAB 431-68

(Interim Report)

**CORROSION STUDY OF BARE AND COATED
STAINLESS STEEL**

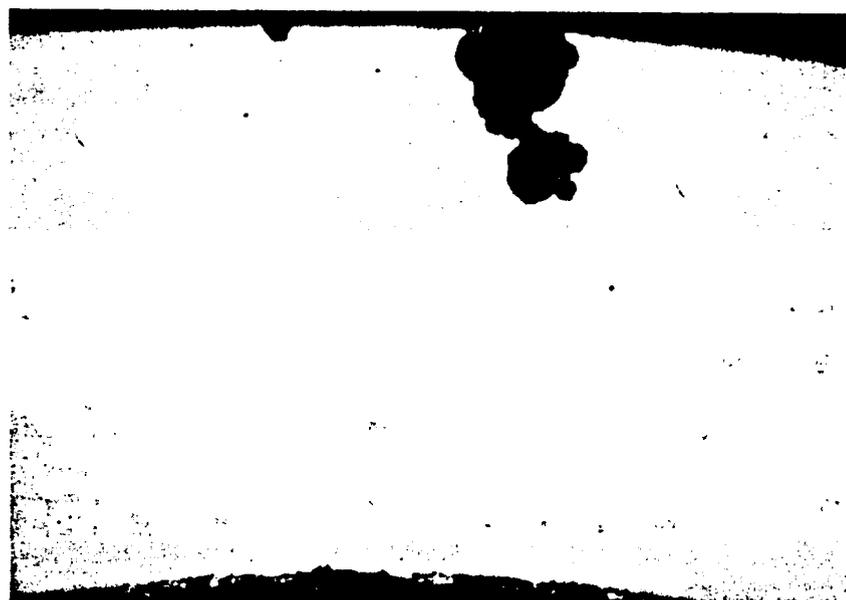
Figure 13. Surface Characteristics and Pit Depth of Type 304L Exposure Sample

Exposed

Sheltered Portion

Cross-Section of Tubing Wall in Deepest Pit Area

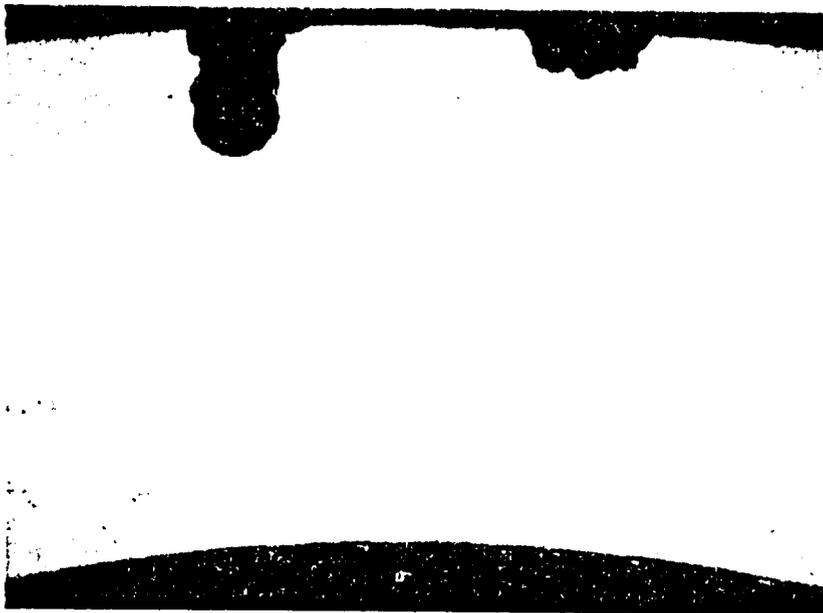
Figure 14. Surface Characteristics and Pit Depth of Type 347 Exposure Sample

Exposed Portion

Sheltered Portion

Cross-Section of Tubing Wall in Deepest Pit Area

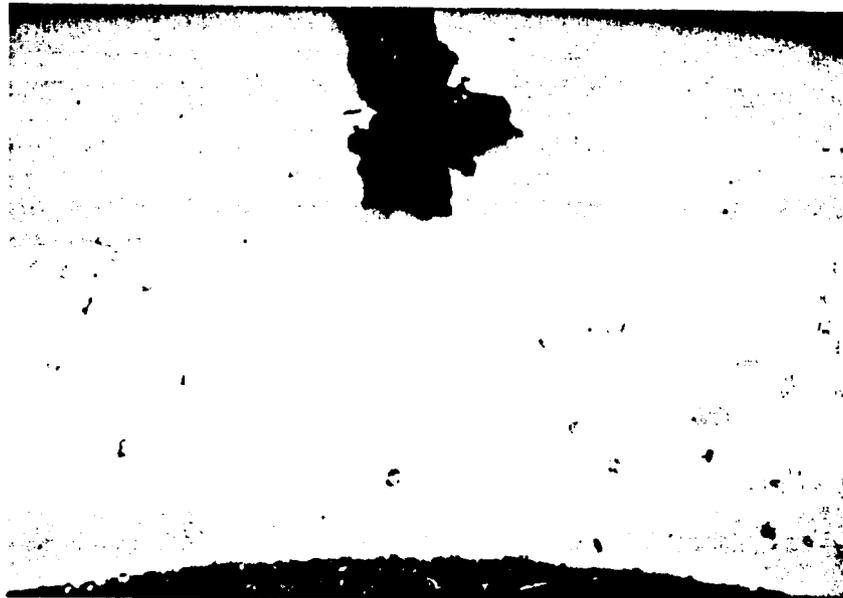
Figure 15. Surface Characteristics and Pit Depth of Type 304 1/8-Hard Exposure Sample

Exposed Portion

Sheltered Portion

Cross-Section of Tubing Wall in Deepest Pit Area

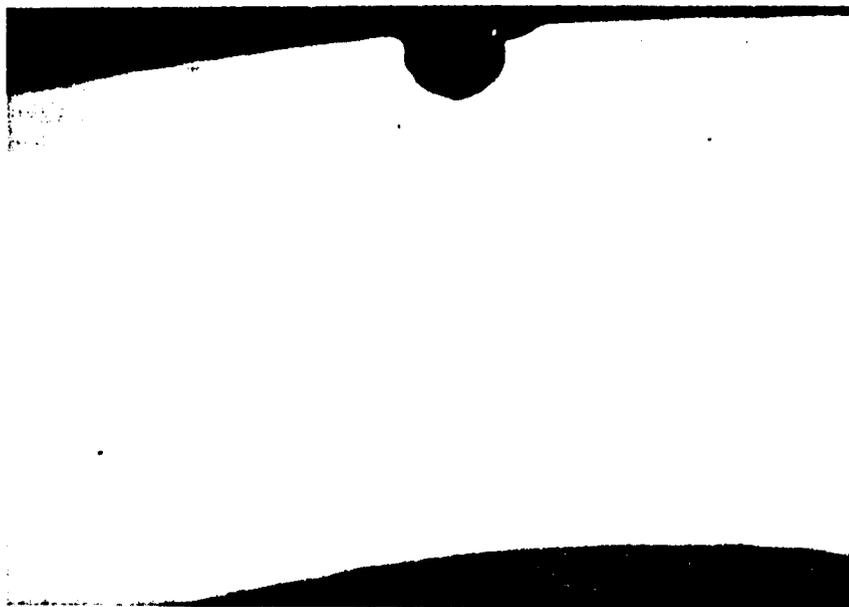
Figure 16. Surface Characteristics and Pit Depth of Type 316 (ASTM- A269) Exposure Sample

Exposed Portion

Sheltered Portion

Cross-Section of Tubing Wall in Deepest Pit Area

As a matter of fact, the deepest pits found to date in any of the samples have been in Type 316L and in the Type 316 (MSFC 10MO 17341, as is shown in Figures 12 and 19. This is not to suggest that Type 316 has a higher pitting rate than the other grades; in another Type 316 sample (Figure 16), no deep pits were found. The evidence cited here does suggest that no single austenitic stainless steel of the grades tested in this program is significantly better than the others for the fluid-systems applications in an environment of the KSC-type.

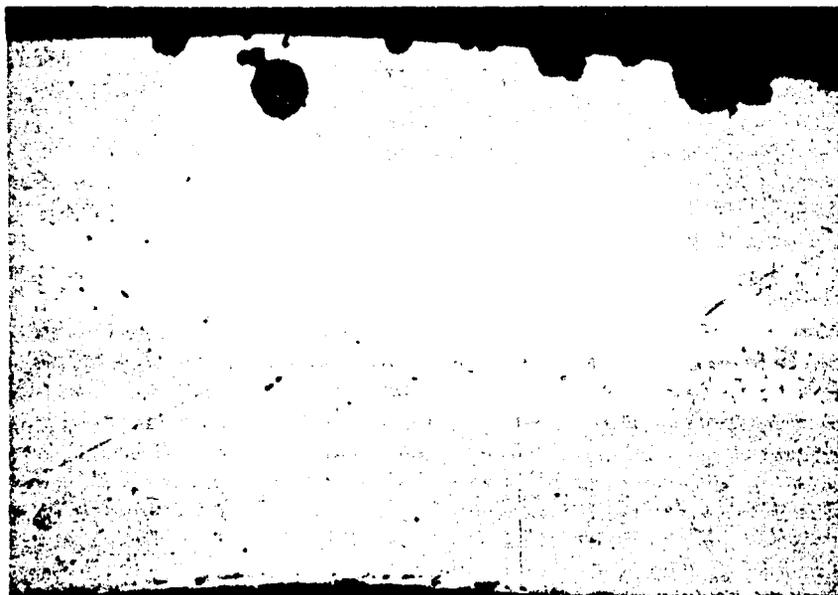
Figure 17. Surface Characteristics and Pit Depth of Type 321 Exposure Sample

Exposed Portion

Sheltered Portion
